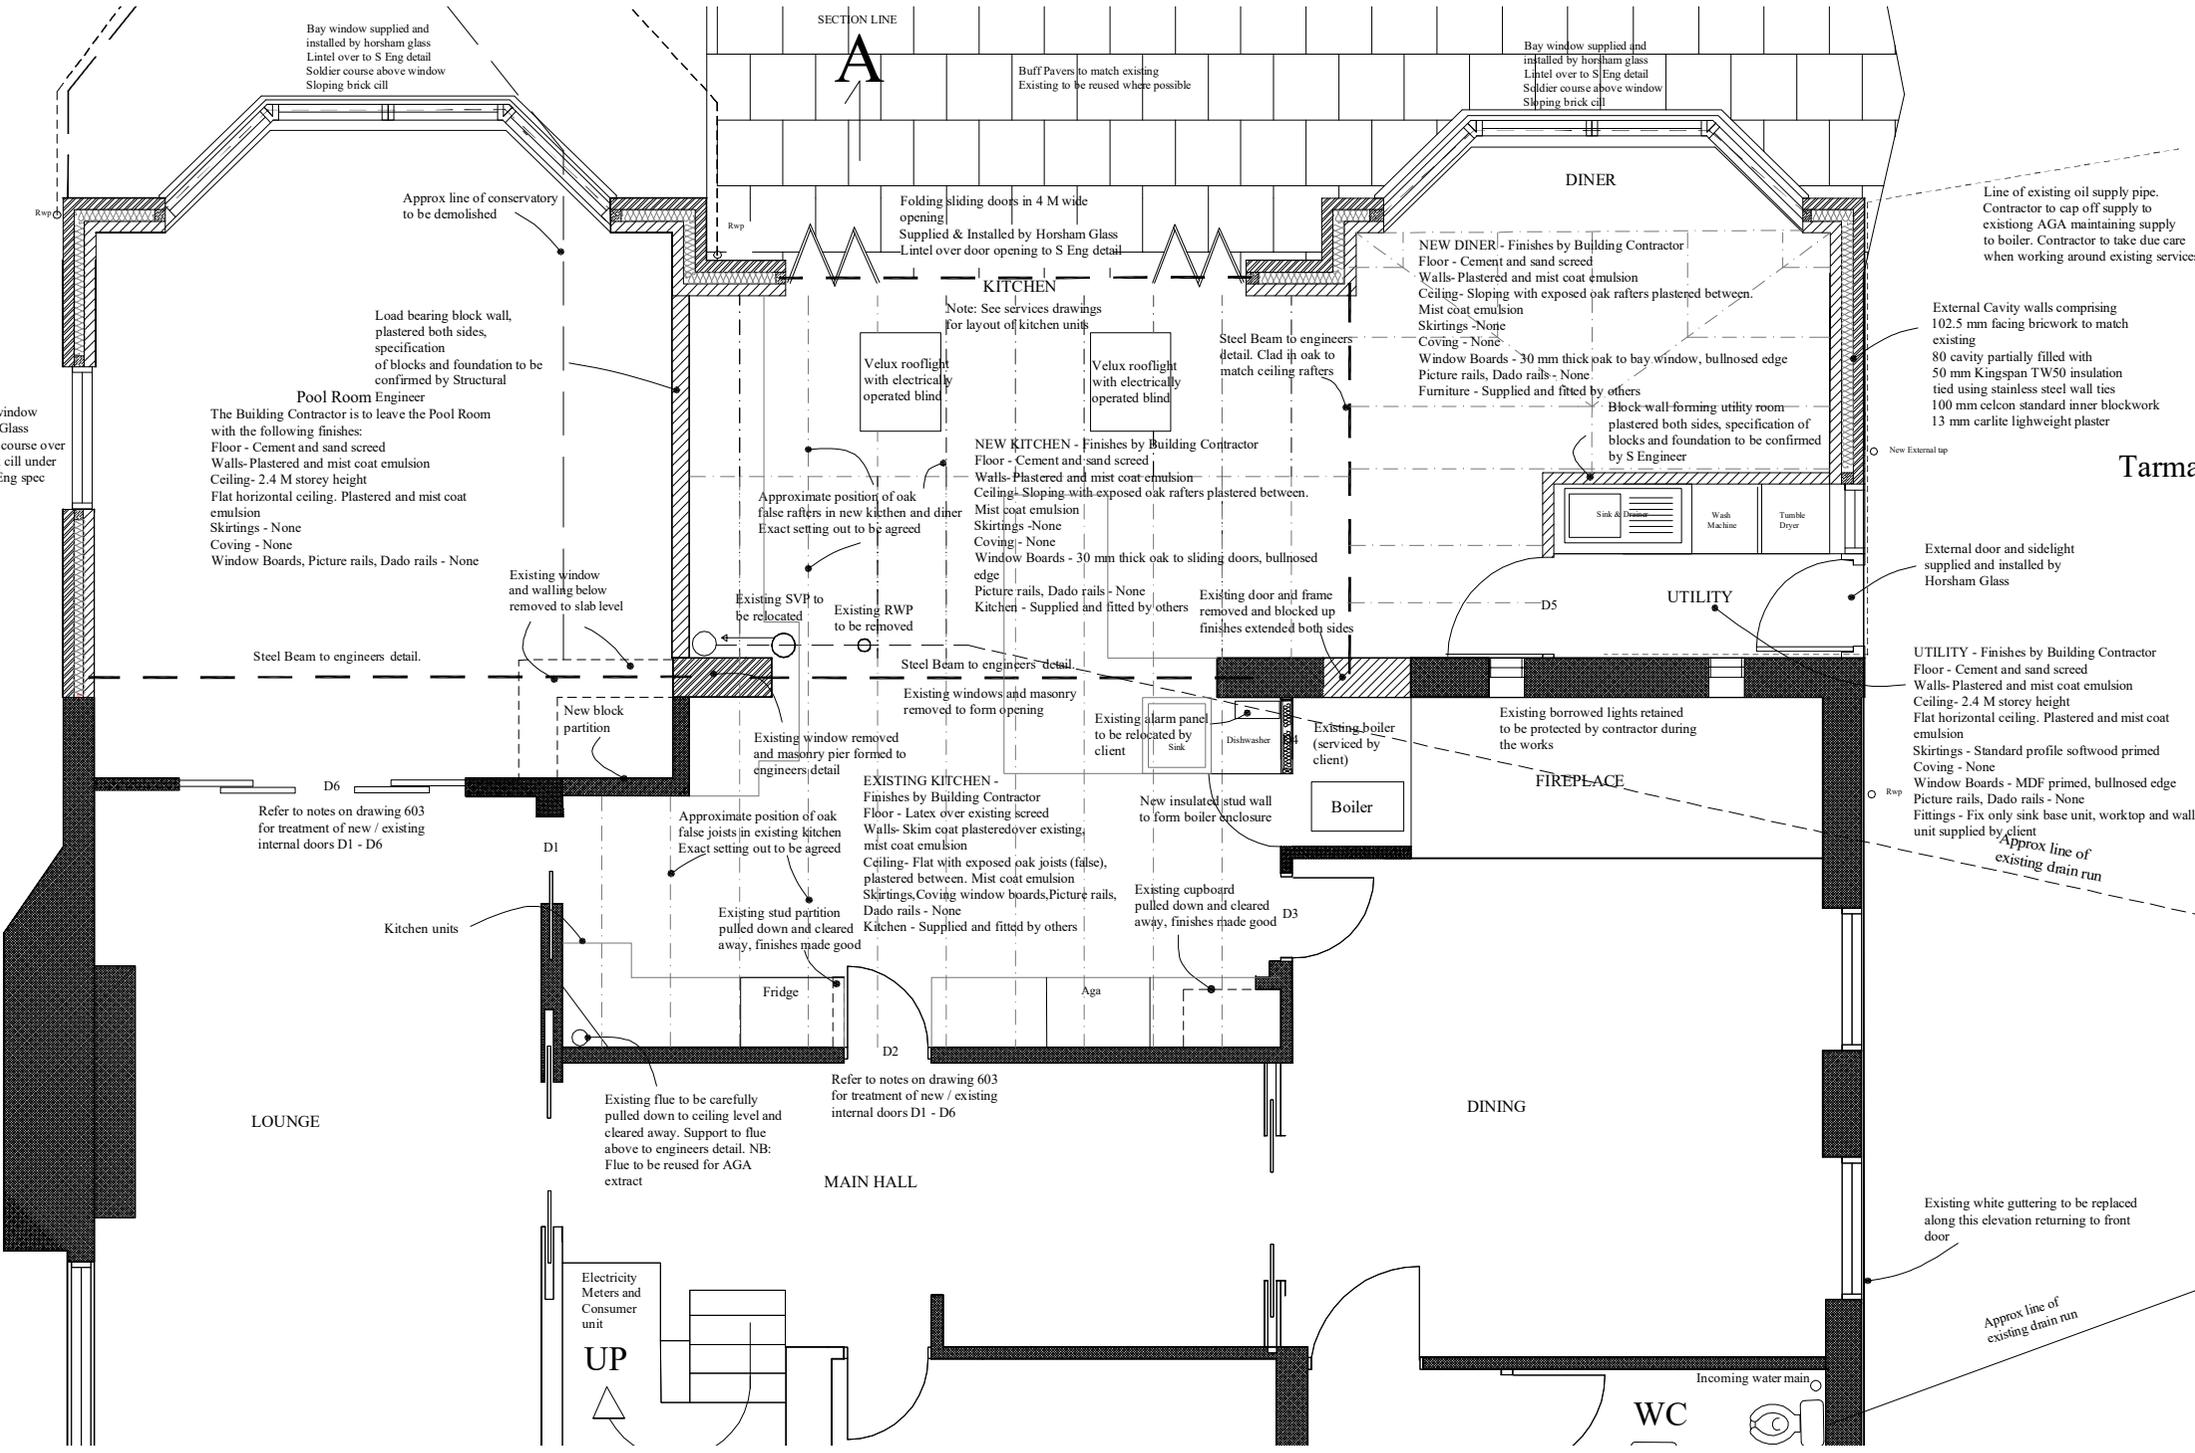
Bay window supplied and installed by horsham glass
Lintel over to S Eng detail
Soldier course above window
Sloping brick cill

Buff Pavers to match existing
Existing to be reused where possible

Approx line of conservatory to be demolished

Load bearing block wall, plastered both sides, specification of blocks and foundation to be confirmed by Structural Engineer

Steel Beam to engineers detail.

Steel Beam to engineers detail. Clad in oak to match ceiling rafters

External Cavity walls comprising 102.5 mm facing brickwork to match existing
80 cavity partially filled with 50 mm Kingspan TW50 insulation tied using stainless steel wall ties
100 mm celcon standard inner blockwork
13 mm carlite lightweight plaster
